**Office of Oversight
Environment, Safety and Health**

*Phase I
Independent Investigation
of the*

Paducah Gaseous Diffusion Plant

Environment, Safety, and Health Issues

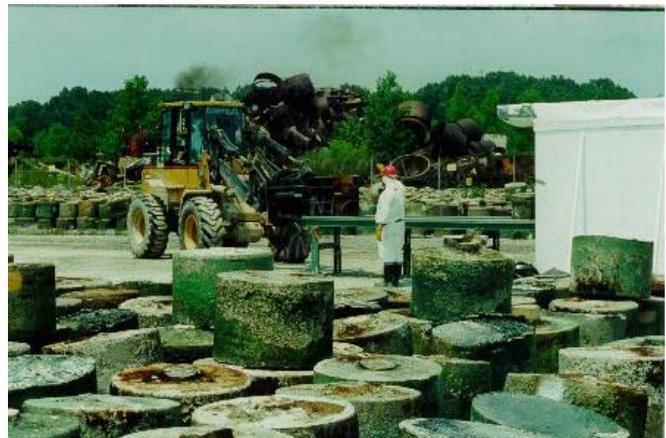
Several thousand tons of nickel and aluminum ingots were produced. These materials are currently stored outside with no protection.

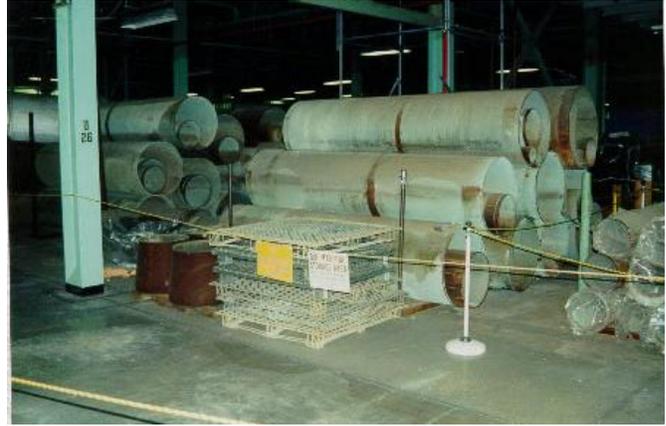
DOE Material Storage Area

- Criticality safety hazards in DOE material storage areas (DMSAs) have not been characterized, analyzed, and resolved even though they were identified more than two years ago.
- Medical personnel have not been sufficiently involved in evaluating hazards to ensure the effectiveness of medical surveillance programs, particularly those for subcontractors.
- Worker training programs do not ensure familiarity with workplace hazards and have not adequately addressed the presence of transuranics (elements, such as plutonium, that have a higher atomic number than uranium). This shortcoming in training may have exacerbated workers' fear of exposure and contributed to instances of mistrust by workers.

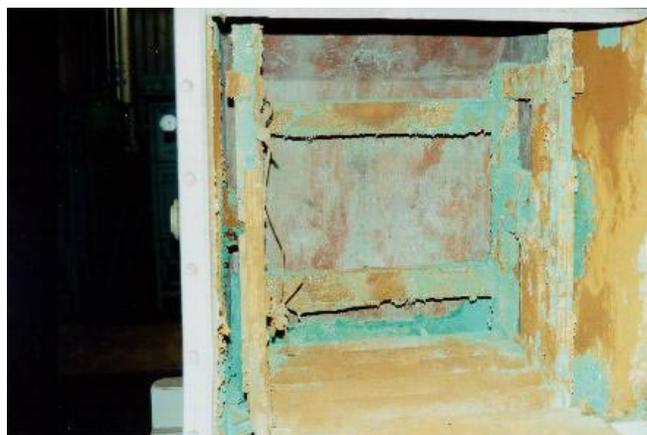
Quantities of uranium materials are clearly evident at product handling points in Building 340.

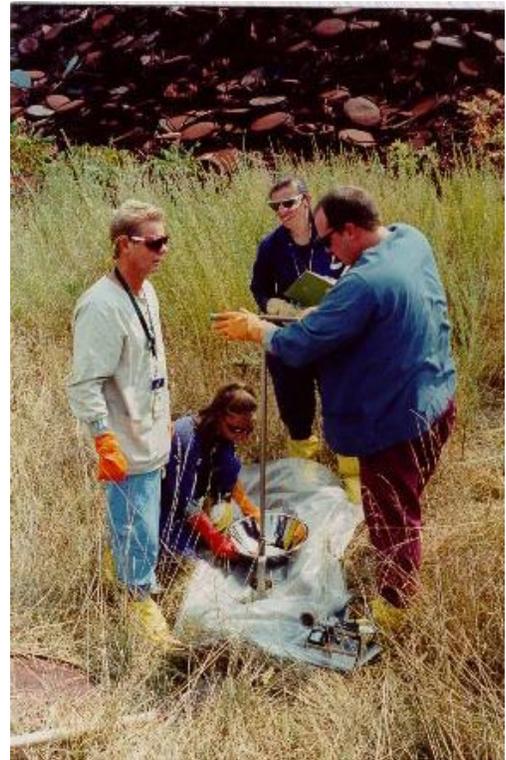
The sampling team collected soil samples at the base of Drum Mountain. Grass areas were surveyed at 8 million disintegrations per minute with visible uranium materials present.

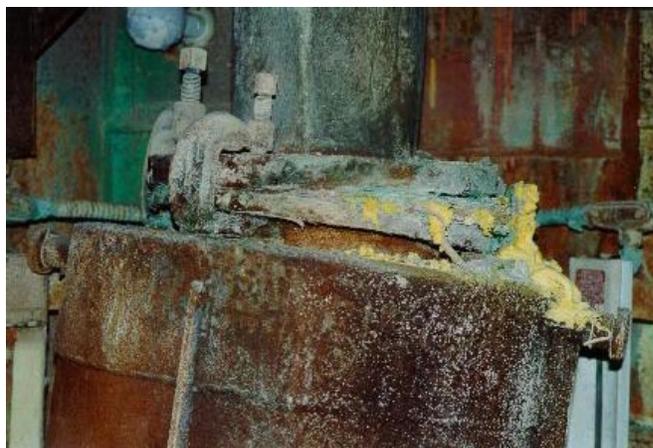
One ash receiver in Building 410 remains in place after 22 years, held in place by corroded C-Clamps. Uranium materials were clearly migrating from the receiver.

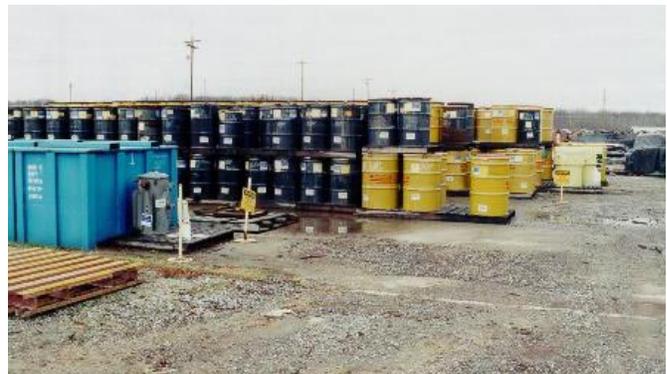
Outdoor drum storage

- A total of 6,444 cubic meters (equivalent to approximately 31,000, 55-gallon drums) of low-level waste are stored onsite at PGDP. This includes 1,775 m³ stored outside in over 8,000 containers that were not designed for long-term storage. Many of the containers stored outside are severely degraded, and some have leaked as a result. Much of the site's low-level waste is not fully characterized for shipment, and some may contain transuranic materials. Disposal of this waste has received low funding priority because there are no regulatory requirements or identified safety concerns requiring near-term disposition. As a result, only 157 m³ have been shipped from the site since 1990. The schedule for completing disposal has subsequently changed from fiscal year 2006 to fiscal year 2012. Additionally, current funding targets assume that no new waste management facilities will be needed to accomplish the site mission. This assumption does not take into account necessary efforts to open, inspect, and characterize the thousands of low-level and mixed waste drums currently stored onsite. Elsewhere in the DOE complex (Rocky Flats Environmental Technology Site and Nevada Test Site), engineered facilities are used to conduct these characterization and segregation efforts. Such facilities would significantly reduce the risk to the workers who open the containers for inspection and characterization.

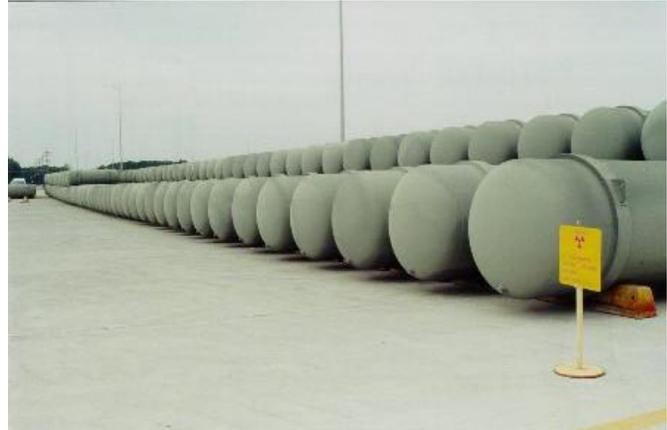
Approximately 37,000 cylinders of UF₆, each containing up to 14 tons, remain stored on site pending conversion to more stable forms.

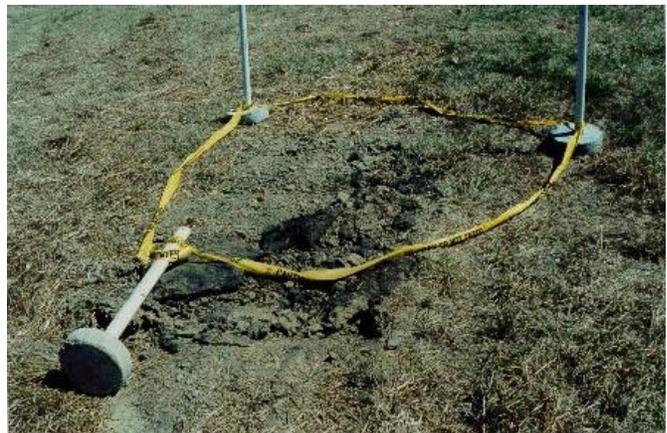
This area was recently discovered near the S&T Landfill. Black "ooze" was discovered to be radiologically contaminated. This area has been covered and posted, pending further investigation.

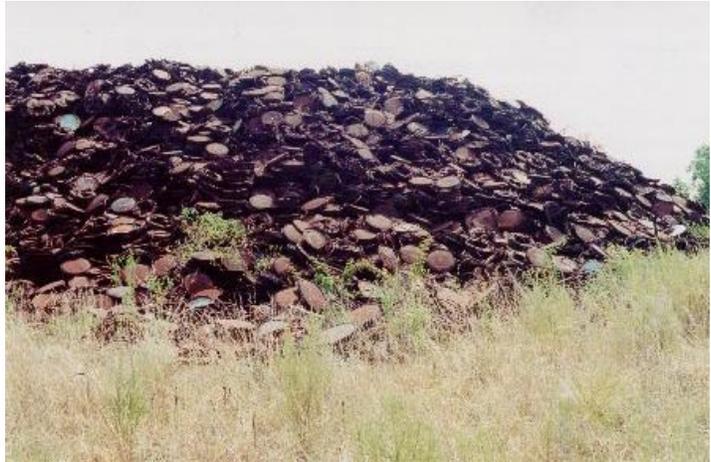
Drum Mountain contains residual uranium materials that are contributing to contamination of the environment.

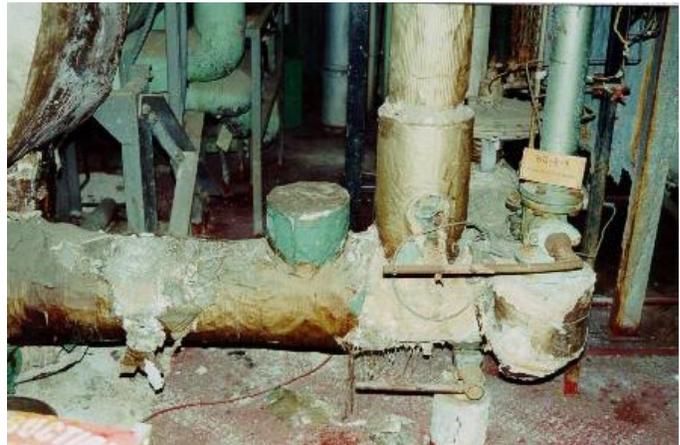
Many locations in shutdown buildings contain degraded lagging probably containing asbestos.

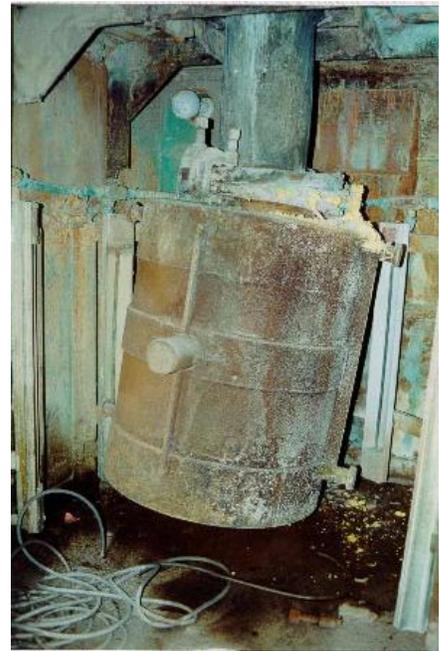
The Building 410 ash receiver, held in place with corroded C-Clamps.

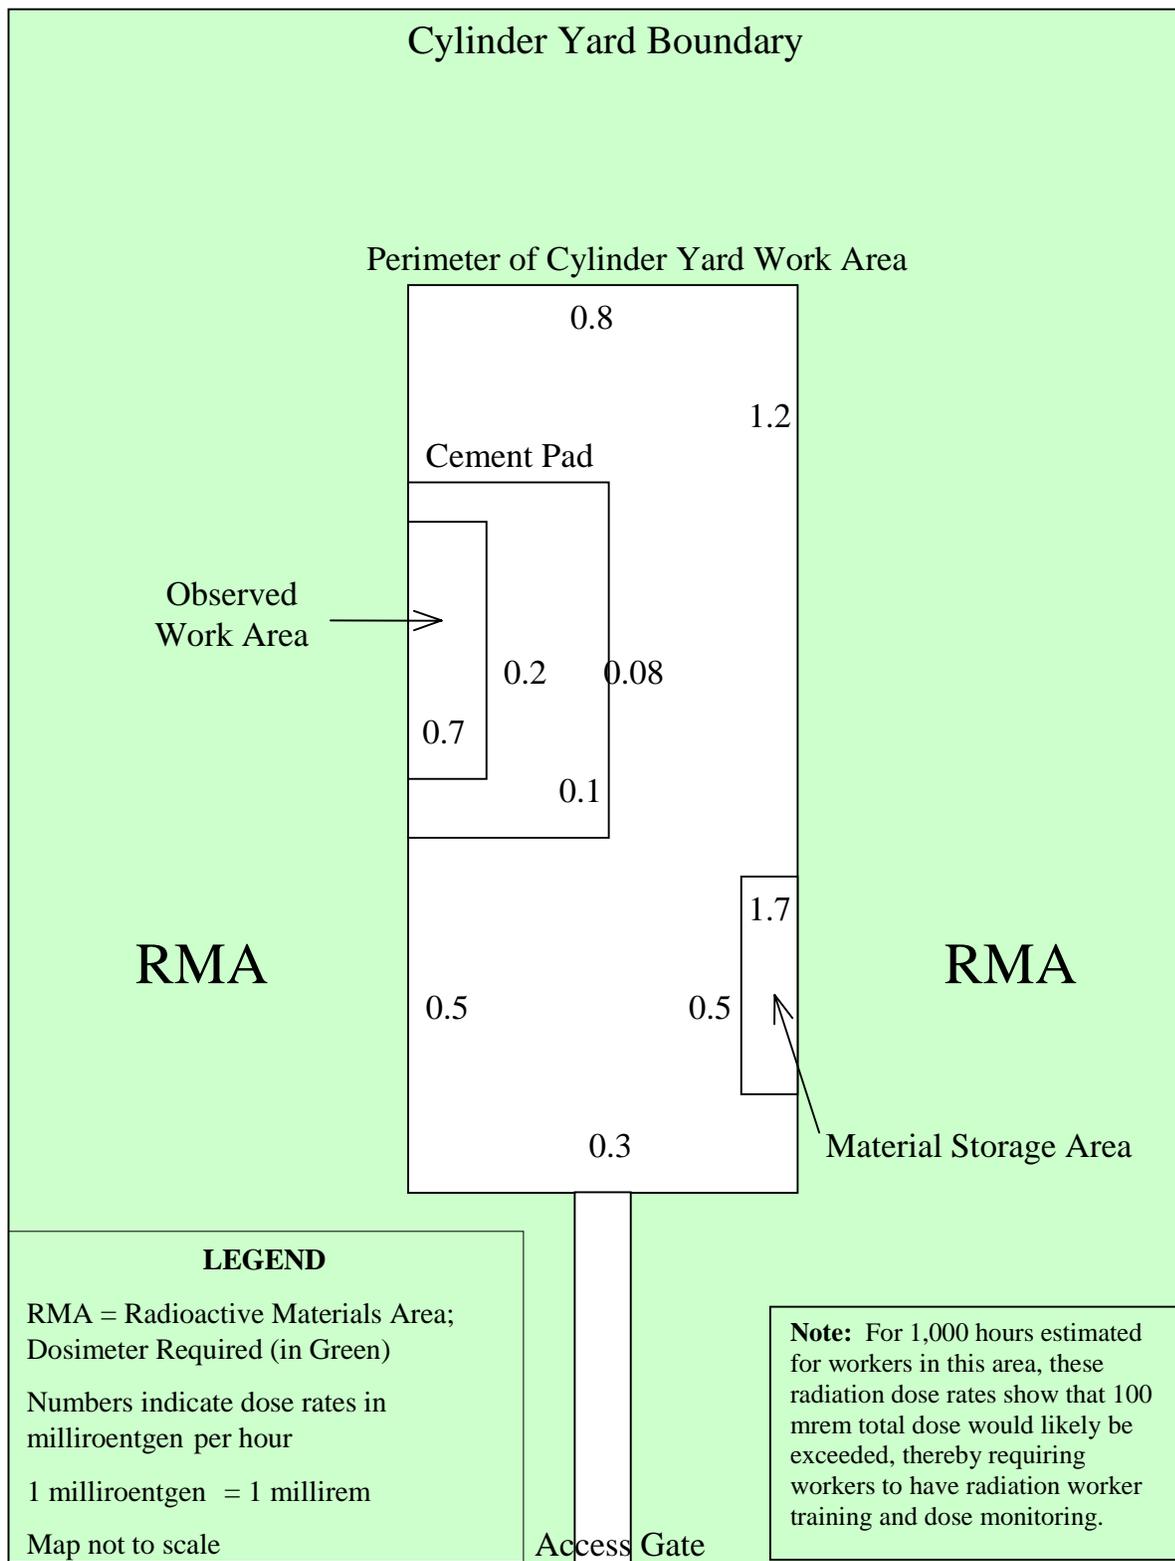
Figure 10. L Cylinder Yard Survey Readings

- Line management's initial determination that no dosimetry or radiological worker training was needed for construction personnel working at the cylinder yard project was inappropriate. This Bechtel Jacobs decision was initially based on an April 1999 survey that focused on the perimeter of the cylinder yard work area. Another survey, taken June 3, 1999, to confirm the initial determination included only the perimeter area and not the interior of the work area. On June 4, 1999, a survey of the interior of the work area inaccurately showed radiation levels a factor of ten lower than those observed by the investigation team on August 30, 1999. Contrary to Bechtel Jacobs' initial assessment, independent dose rate measurements of the work area by the investigation team (see Figure 10) indicated that, based on an anticipated six-month job duration, worker doses would likely exceed the 100 mrem threshold for such controls, and workers should have been monitored and provided Radiation Worker I training. This finding led to a shutdown of work and implementation of radiation monitoring (thermoluminescent dosimeters) and radiological training for workers. One worker escort who was monitored recorded a dose of 24 mrem in 35 days on the job in May and June. A subsequent Bechtel Jacobs evaluation indicated that worker doses would probably not have exceeded 100 mrem. However, this evaluation assumed an average work area dose rate that was two to three times lower than the dose rate that the investigation team observed in the work area.

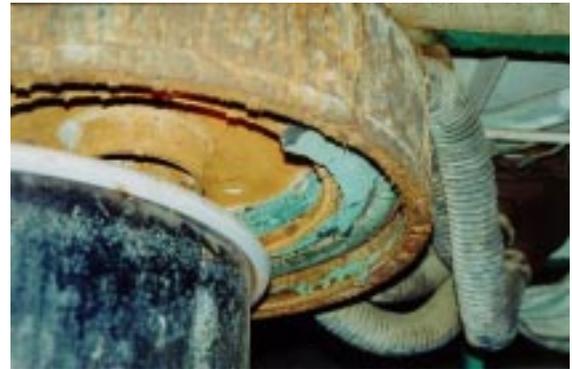
Subcontractor personnel attributed the lack of postings to inadequate funding.

Uranium materials at product handling points in Building 340.

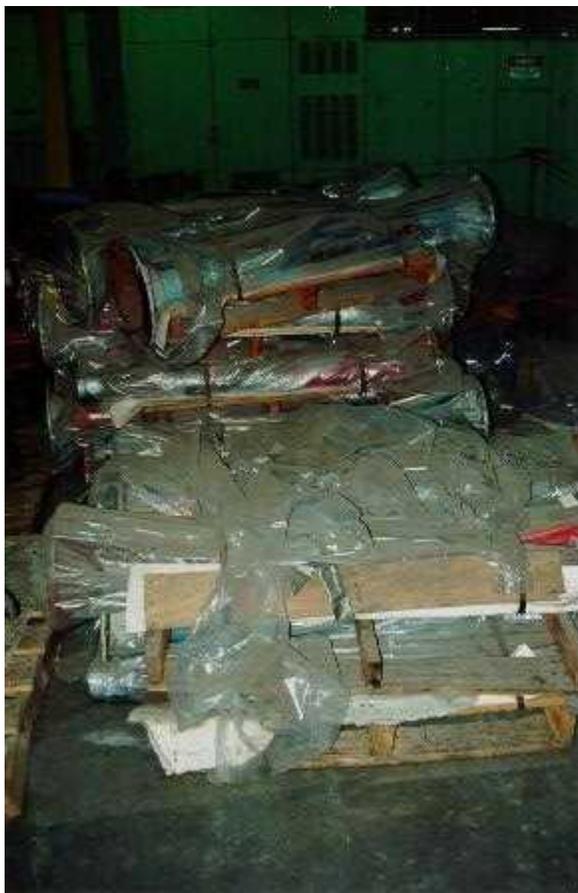
DOE Material Storage Area

- In several of the DMSAs, the risk of a criticality accident is not known. However, non-destructive assay data obtained from some, but not all, of the equipment that originated at Portsmouth or Oak Ridge indicate that there is insufficient localized fissile mass in the equipment surveyed to make a criticality accident possible.
- The type, quantity, enrichment, and configuration of fissionable materials in these areas have not been fully characterized.

Background. Uncharacterized radiological and chemical equipment, materials, and waste in DMSAs (as shown in the picture) continue to present unnecessary and avoidable risk to workers and the environment. In 1996, DOE accepted responsibility for large amounts of legacy materials (e.g., uncharacterized scrap, equipment, drums, and other wastes) that were stored in the leased facilities so that USEC could obtain a certificate of compliance from the NRC. These materials are currently stored in 148 DMSAs located across the site, including “islands” within in the USEC operating facilities. Eleven DMSAs have been identified as high-priority areas based on nuclear criticality safety concerns. These 11 DMSAs include equipment that could contain large deposits and fissile materials with enrichments as high as 93 percent.

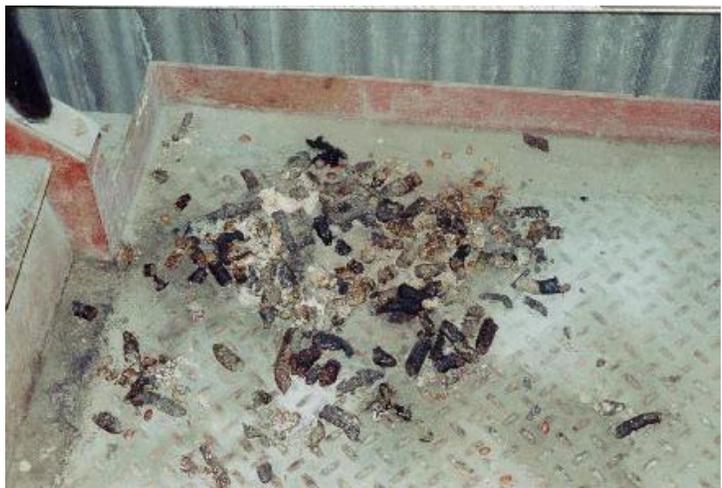
Animal material in Building 340 poses potential health effects to workers.

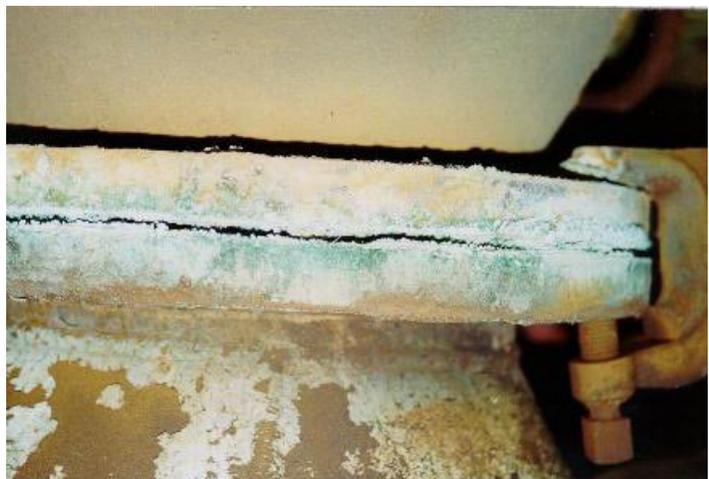
Building 410 corroded ash receiver
