**Office of Oversight
Environment, Safety and Health**

*Phase I
Independent Investigation
of the*

Paducah Gaseous Diffusion Plant

Environment, Safety, and Health Issues

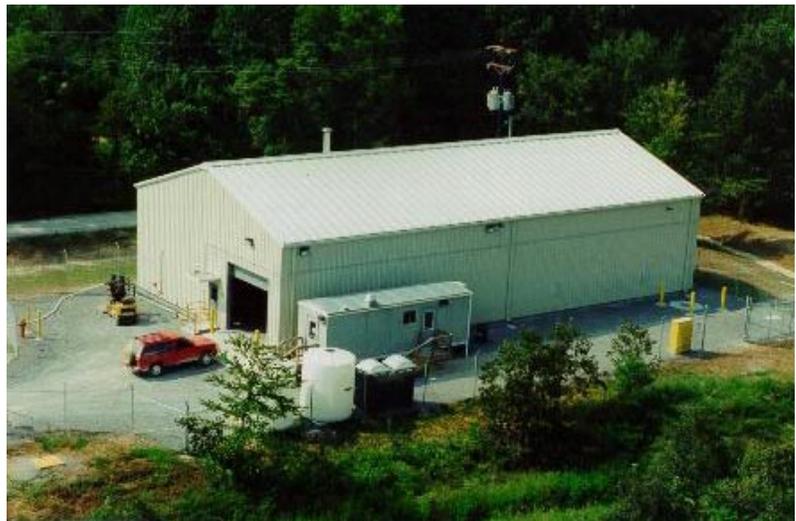
The pump-and-treat facility for the Northeast Plume was installed to slow the spread of TCE.

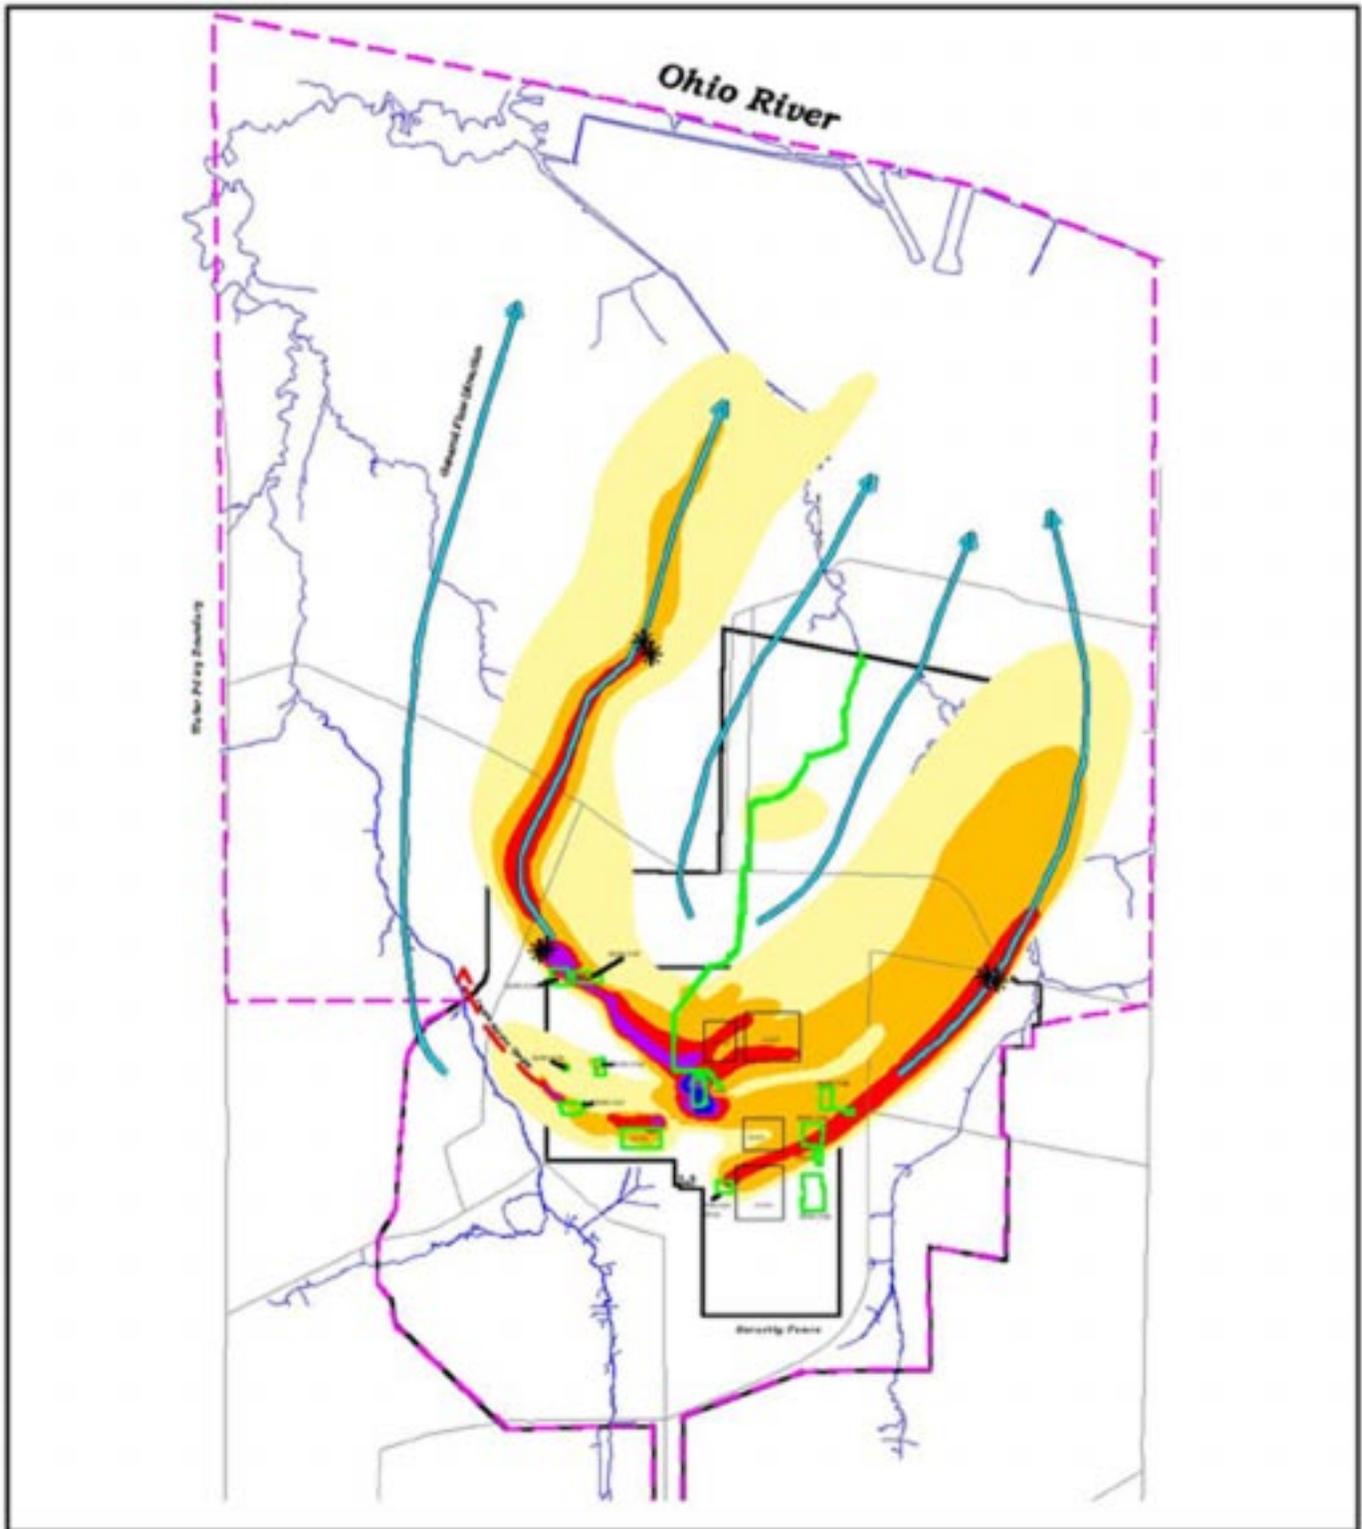
Paducah TCE Contamination in The RGA

- Several sources are responsible for the groundwater contamination in the two major plumes. A major contributor to the Northwest Plume is a facility that used large volumes of TCE for degreasing equipment (Building C-400). High concentrations of TCE dissolved in groundwater near C-400 and characterization studies suggest that TCE exists in pure form in the subsurface. Building C-400 is also a major source of technetium-99 contributing to the

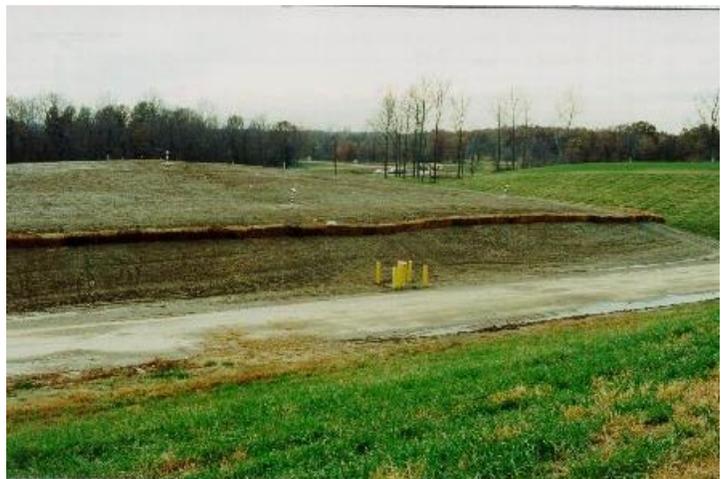
Existing landfills have been capped, monitoring wells have been put in place, and controls have been installed to limit erosion of sediments and spread of contamination.

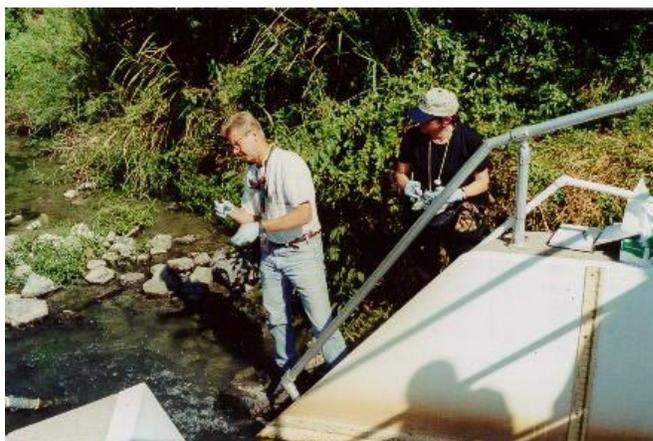
Radioactivity analyses for surface waters showed relatively low concentrations for all isotopes, with the North-South Diversion Ditch sample showing the highest levels of uranium and technetium-99 at 37 mg/L (12.5 pCi/L) and 26 pCi/L, respectively. Transuranic and thorium isotopes were either not detected or were present in very low concentrations, consistent with prior sampling results conducted by the site. For comparison purposes, one may note that the surface water results are all well below the Derived Concentration Guidelines (DCGs) established by DOE Order 5400.5. The DCGs

Sampling for volatile organics at K001 Outfall

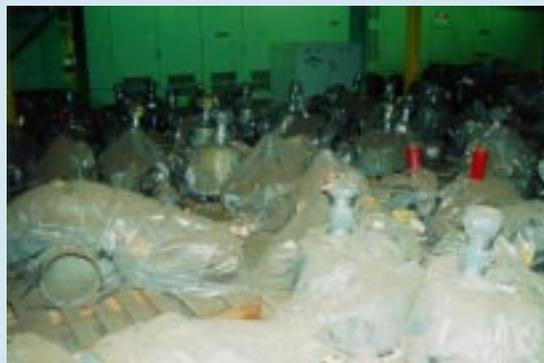
DOE Material Storage Area Weaknesses

Background. Uncharacterized radiological and chemical equipment, materials, and waste in DMSAs (as shown in the picture) continue to present unnecessary and avoidable risk to workers and the environment. In 1996, DOE accepted responsibility for large amounts of legacy materials (e.g., uncharacterized scrap, equipment, drums, and other wastes) that were stored in the leased facilities so that USEC could obtain a certificate of compliance from the NRC. These materials are currently stored in 148 DMSAs located across the site, including “islands” within in the USEC operating facilities. Eleven DMSAs have been identified as high-priority areas based on nuclear criticality safety concerns. These 11 DMSAs include equipment that could contain large deposits and fissile materials with enrichments as high as 93 percent.

- Responsibilities and accountabilities for DMSAs have not been clearly established.
- Although problems and corrective actions were identified and submitted to the Paducah Site Office in 1997, an acceptable plan and schedule for disposition of the materials have not been developed.
- DOE has not provided the funds to disposition the materials.
- Almost no actions to disposition the material have been accomplished.
